L'Aquila, Italy Earthquake Journal

H. Kit Miyamoto
Global Risk Miyamoto

Journal Entry #1

April 14 - L'Aquila, Epicenter

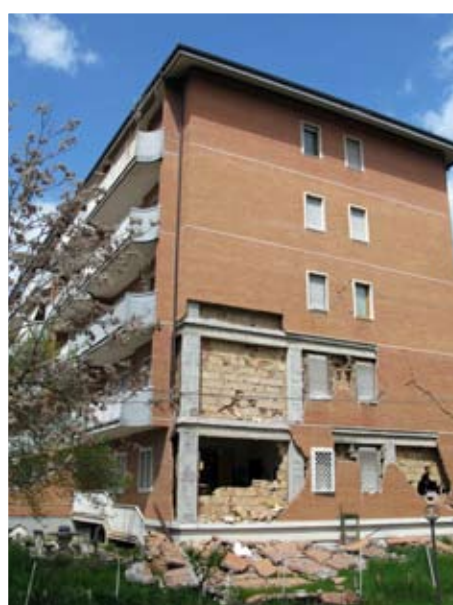
11:25 am, First Failure

We witnessed the first major earthquake damage along the road near the highway exit. A 4-story concrete apartment building that did not collapse, but masonry walls at the first and second floors had crumbled to the ground. In this area, many residential and commercial buildings have a concrete-beam-and-column system to carry both gravity and earthquake forces to the ground. We call this a moment frame system. The spaces between the beams and columns are then filled with unreinforced masonry to create the architectural walls. Unfortunately and unknowing to the builder, these walls stiffened this building and took almost all earthquake forces. But the walls were not engineered for it and collapsed. This damage rendered the building inhabitable. This is a well known phenomenon; which again injured and killed a score of people in this earthquake.

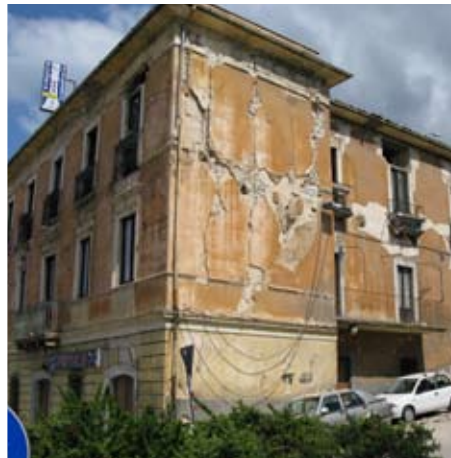
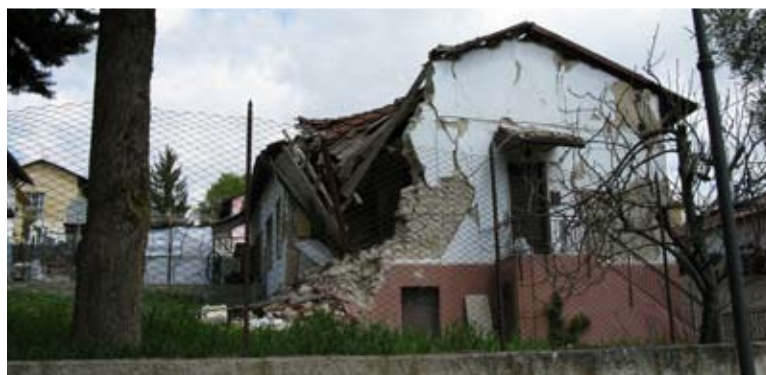
12:35 pm, Collapsed Buildings

We drove up to a hill top residential area that we had spotted damaged buildings. It appeared that buildings at hilltops were more severely damaged than ones in the low lands. Peter Yanev explained that this effect is focusing. At hilltops, earthquake energy can be intensified or focused. I observed this in the 2007 Sumatra earthquake.

We saw dozens of midrise buildings with damage ranging from collapsed infill walls to minor cracking. We also saw many brick houses, where the wall corners cracked and collapsed. Corners are dangerous areas for brick construction. Walls from orthogonal directions restrained each other and cause failure.

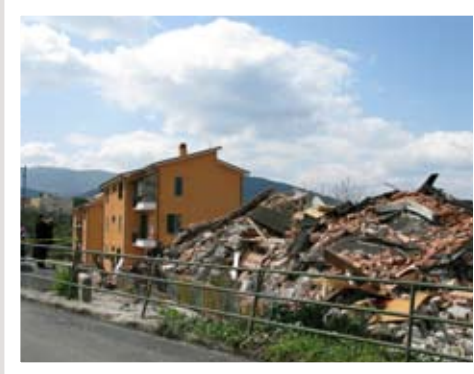
Just as we were about to drive away, I spotted a collapsed building pile. Locals told us that it was a 3-story building. The building was constructed of unreinforced brick walls supporting concrete floors - one of the most dangerous building types throughout the world. I saw the same building system killed thousands of school children in 2008 Sichuan, China earthquake. Different country, but the same dangerous building type kills many.

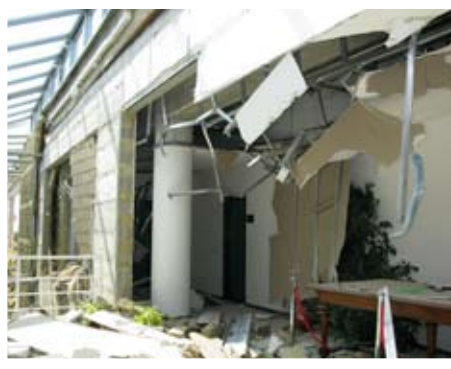
There was widespread destruction inside. Many architectural concrete masonry walls collapsed. So did suspended ceilings. Simply, there were no connections or braces to stabilize these walls and ceilings. I saw numerous concrete masonry walls collapsed onto students' and faculty desks. If this earthquake had happened when school was in session, it would have killed many students.

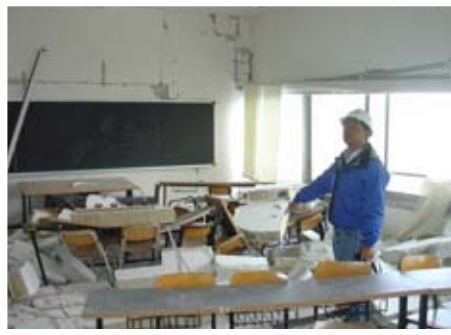
The building didn't have much structural concrete frame damage, but we as engineers failed the public that it was suppose to protect. In the midst of this damage was a continuous eerie alarm that echoed in this abandoned building.

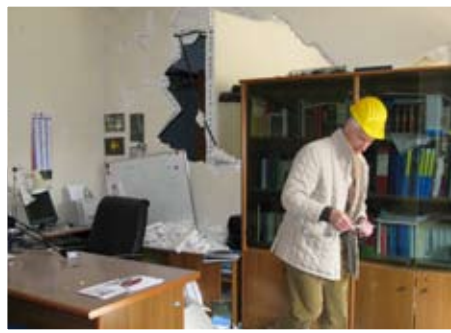
I saw less architectural damage in this older building. It was constructed of concrete frame with infill masonry walls. These walls helped to dampen the earthquake forces. One of the professors went up stairs with us. He led us to his old office at the third level where the infill wall was heavily damaged and collapsed on his desk. He removed his young son's picture from the wall and we soon departed.
