L'Aquila, Italy Earthquake Journal

H. Kit Miyamoto
Global Risk Miyamoto

Journal Entry #4

April 16, 2009, 7:30 am - The Journey to the Epicenter

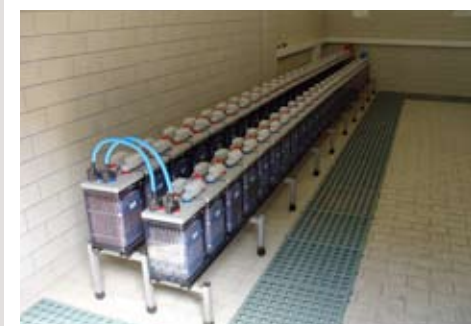
The plant buildings and structures were well engineered steel structures that appeared undamaged. These were the only steel

framed buildings that we have observed so far. Some of the equipment, particularly the generation related equipment was anchored properly. Much of the other equipment, however was not anchored properly for earthquakes. We pointed out some of the weaknesses in equipment systems. The emergency battery racks was not braced and the batteries were not protected against falling off their racks. Batteries seem so trivial, but are crucial for turbine operations after an earthquake triggered stoppage.

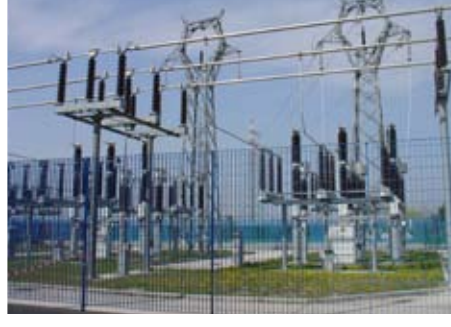
The plant substation is owned by the national transmission company. The substation equipment had no earthquake design to speak of. Most of the various ceramics were interconnected with rigid busses instead of flexible connections

and would have quickly failed had the earthquake been stronger. When the ground starts to shake, ceramic insulators move independently of each other, and if restrained, the differential movement will break the brittle ceramics. Power doesn't flow when ceramics fail. The transformers in the station were also not anchored. All that will result in business interruptions in future earthquake. Fortunately, there are many seismic options and procedures. We went over some of these with the plant manager, who was very grateful. I think he will implement many of our suggestions to improve the reliability of this plant for future large earthquakes.

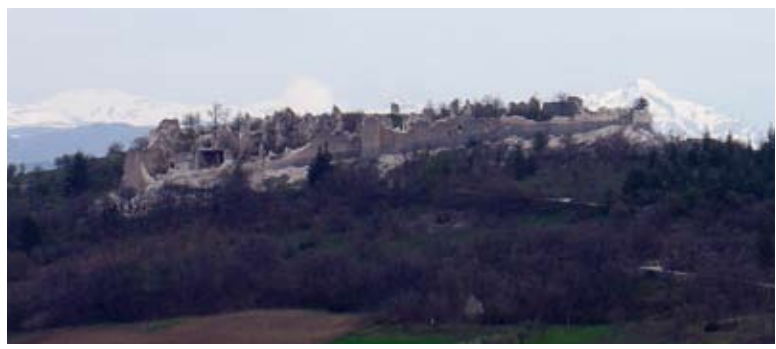
We approached the town of San Panfilo d'Ocre. Ilbe spotted a ruined 10th century castle on a nearby hilltop. From a distance, we can see that the top of ancient walls had collapsed. It is sad to see such heritage lost, but this will happen without retrofit. We continued on through the deserted but undamaged village, and finally met the villagers at the end of the road, in a blue-tent refugee center. We tried to get to the castle for a closer look, but were stopped by a road block.

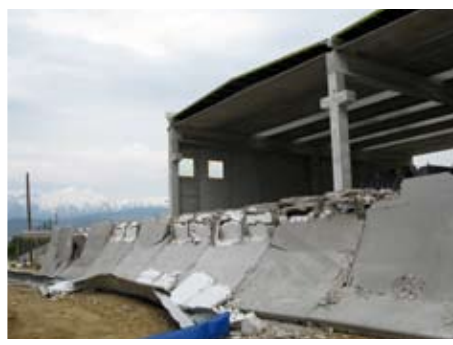
ted a heavily damaged, newly constructed industrial building. It was a precast concrete building and the structural system was very similar to the one we investigated yesterday. The concrete walls were peeled off by the earthquake and crumbled to the ground.

The concrete frame shifted in the earthquake and dropped the concrete roof planks to the ground. Upon closer inspection, we saw only two small steel connections tying the walls to the roof. Obviously, these were not strong enough to resist the earthquake forces. This new industrial building was in a neighborhood of older residential buildings that had no damage. As noted yesterday, buildings of this type have very little earthquake resistance.

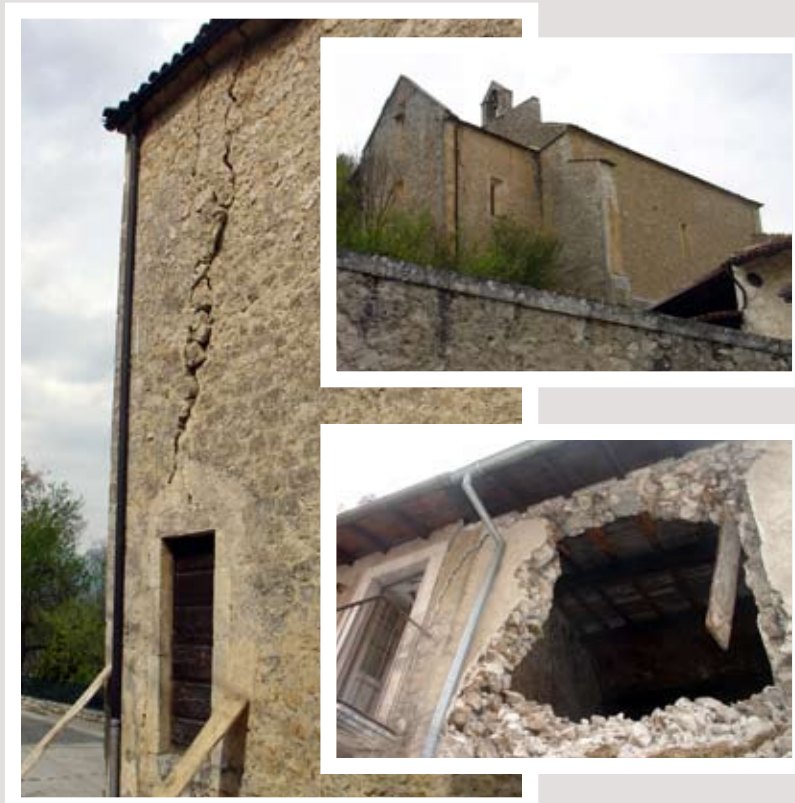
From the L'Aquila valley, we drove up to the medieval town of Fossa; which has a 13th century church at the town entrance. There was a large gash at the wall corner and major damage to the bell tower. This was similar to the damage we witnessed in L'Aquila's old city center. An Italian TV crewed approach and asked about our findings. We gave them a short commentary and continued on with our investigation.

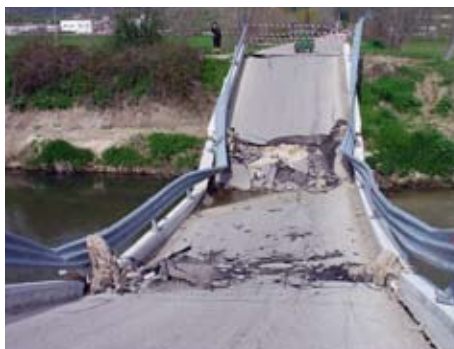
Soon we were in the L'Aquila valley near Poggio Picenze, not far from the epicenter. We spotted a large industrial complex in the distance and decided to investigate. As we drove through a country road toward Poggio Picenze, our progress was suddenly stopped by a collapsed bridge over a small river. It was a strange sight. The concrete bridge had pancaked and rested on the river, with its deck twisted in agony. The bridge's columns

had punched through the deck. Peter quickly climbed down the fallen bridge to study the damage close up. He was promptly asked to leave by a fireman who was guarding the bridge. Peter is 62 years old. I greatly respect his passion for engineering.

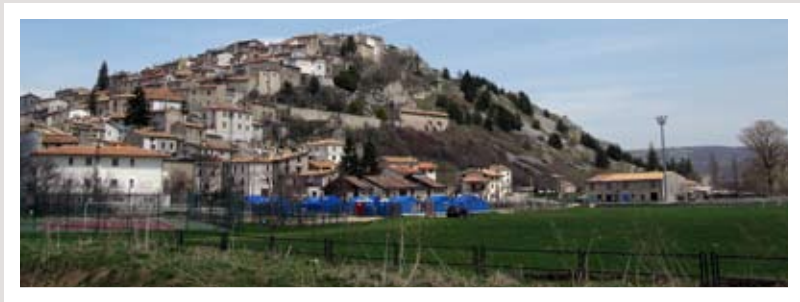
We just drove through an abandoned town named Sant'Eusanio Forconese. Its town center was on a hill top and was totally destroyed. The scene reminded me of a World War II movie. It looked like a bomb had ripped through the main street. I don't know how many people died here since there was no one to ask.

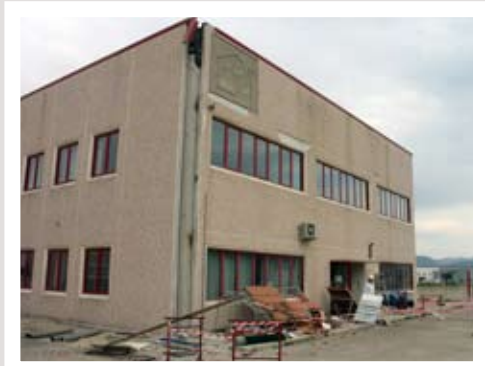
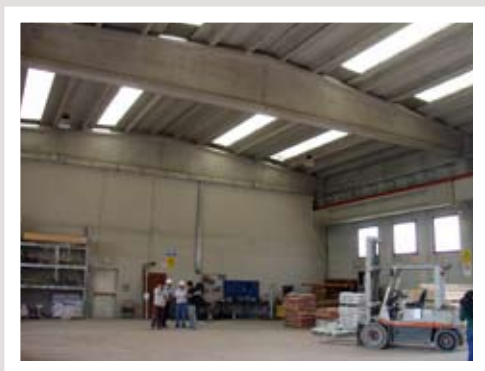
At Fiume Aterno, we surveyed an industrial building at the east end of town. I found the corners of the precast walls had torn away from the building and fell to the ground. The owner came out from the building and looked very annoyed initially, but soon warmed when Ilbe told him that we were engineers from United States. We learned that this was a family owned factory and manufactured construction materials ranging from wood beams to steel rebar. He invited us into the building and introduced us to his son Scimia, who recently graduated from engineering school.

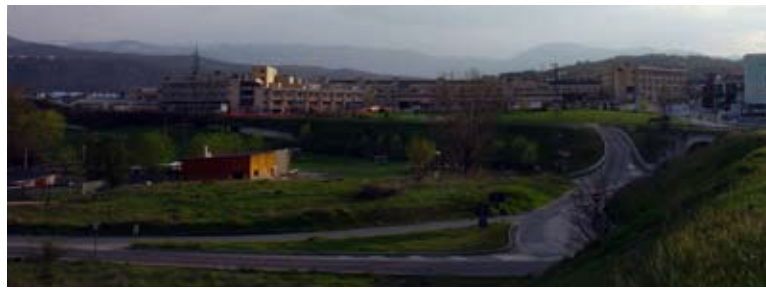
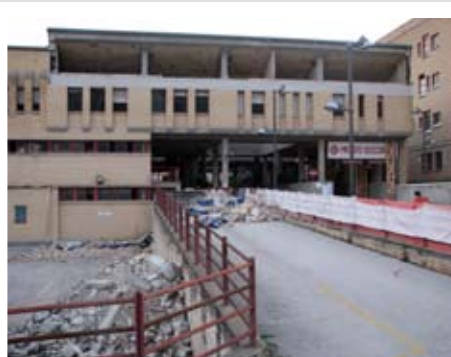
We reached a large hospital on the west side of L'Aquila. It is a 3-story modern hospital that seem undamaged from a distance. But once we got to the entrance, we can see that the walls at the top level had collapsed onto the emergency entrance area, knocking down the large “emergency” sign. This scene reminded us of the emergency canopy collapse at the Olive View Hospital in the 1971 M6.7 San Fernando, California earthquake; which heightened earthquake awareness in California engineers and pioneered the development of today’s seismic codes.

With exterior walls gone, the concrete beams and columns were exposed. These walls were masonry infill walls similar to those that we saw at the college on day one. The hospital was dark and totally deserted. The ground motion here was not strong enough to collapse the structural system, but the unanchored masonry walls didn’t have a chance. Interestingly, other buildings nearby didn’t have much damage—a testament to the low ground motions.

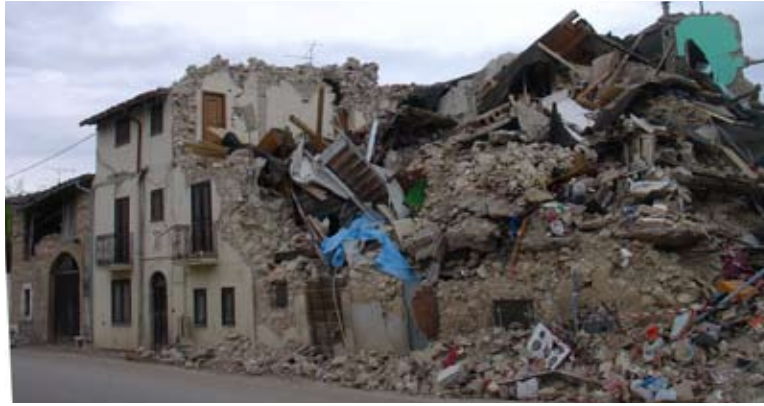
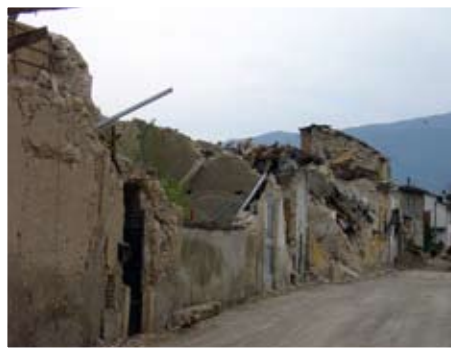
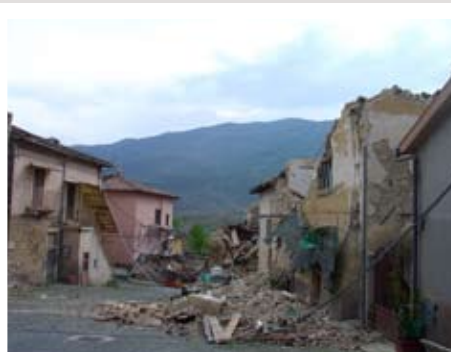
Onna is a small village in a valley near a river. I couldn't believe my eyes when we got there. Many buildings were either totally collapsed or are

about to collapse. Soft soils in this river meadow area may have contributed to the higher ground acceleration and destruction. Earthquake motions tend to increase in soft soil areas. These residential buildings were made of unreinforced brick and concrete floors, one of the most dangerous building types. This same system killed many of 100,000 in China last year. The lesson is repeated here. We spoke with some police officers who explained that over 40 people were killed in this village of 300. We saw a 3-story building completely leveled to the ground. This type of collapse doesn't allow people any chance to escape. I smelled the familiar sweet scent of crushed buildings, dust and belongings.
