# 2007 West Sumatra Earthquake

Reconnaissance Report

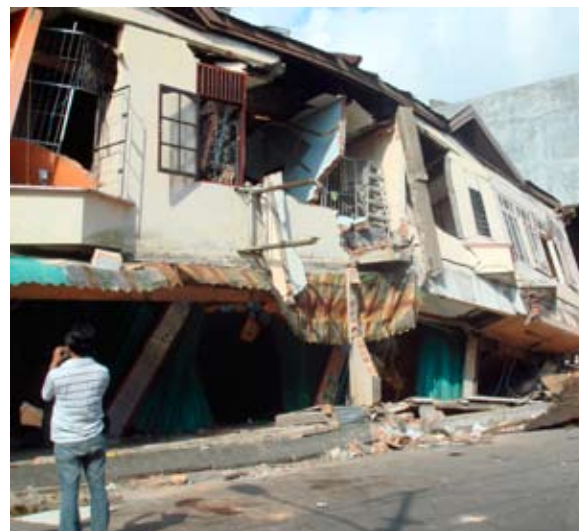
**Figure 6.** This commercial/residential structure used URM framing. The lateral-story stiffness and strength were significantly less for the upper floors and resulted in a soft-story collapse of the first story.

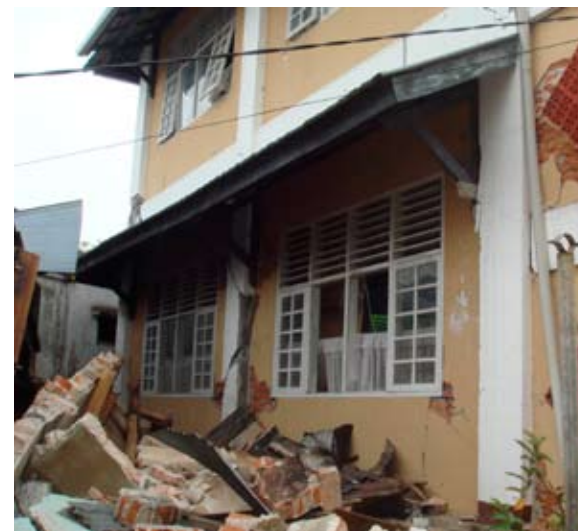
**Figure 7.** The presence of URM infill dramatically alters the seismic response of concrete frames. The infills reduce the clear height of the columns from story height to the height between solid infills. This short-column effect prevents development of full flexural capacity and induces brittle shear failure.

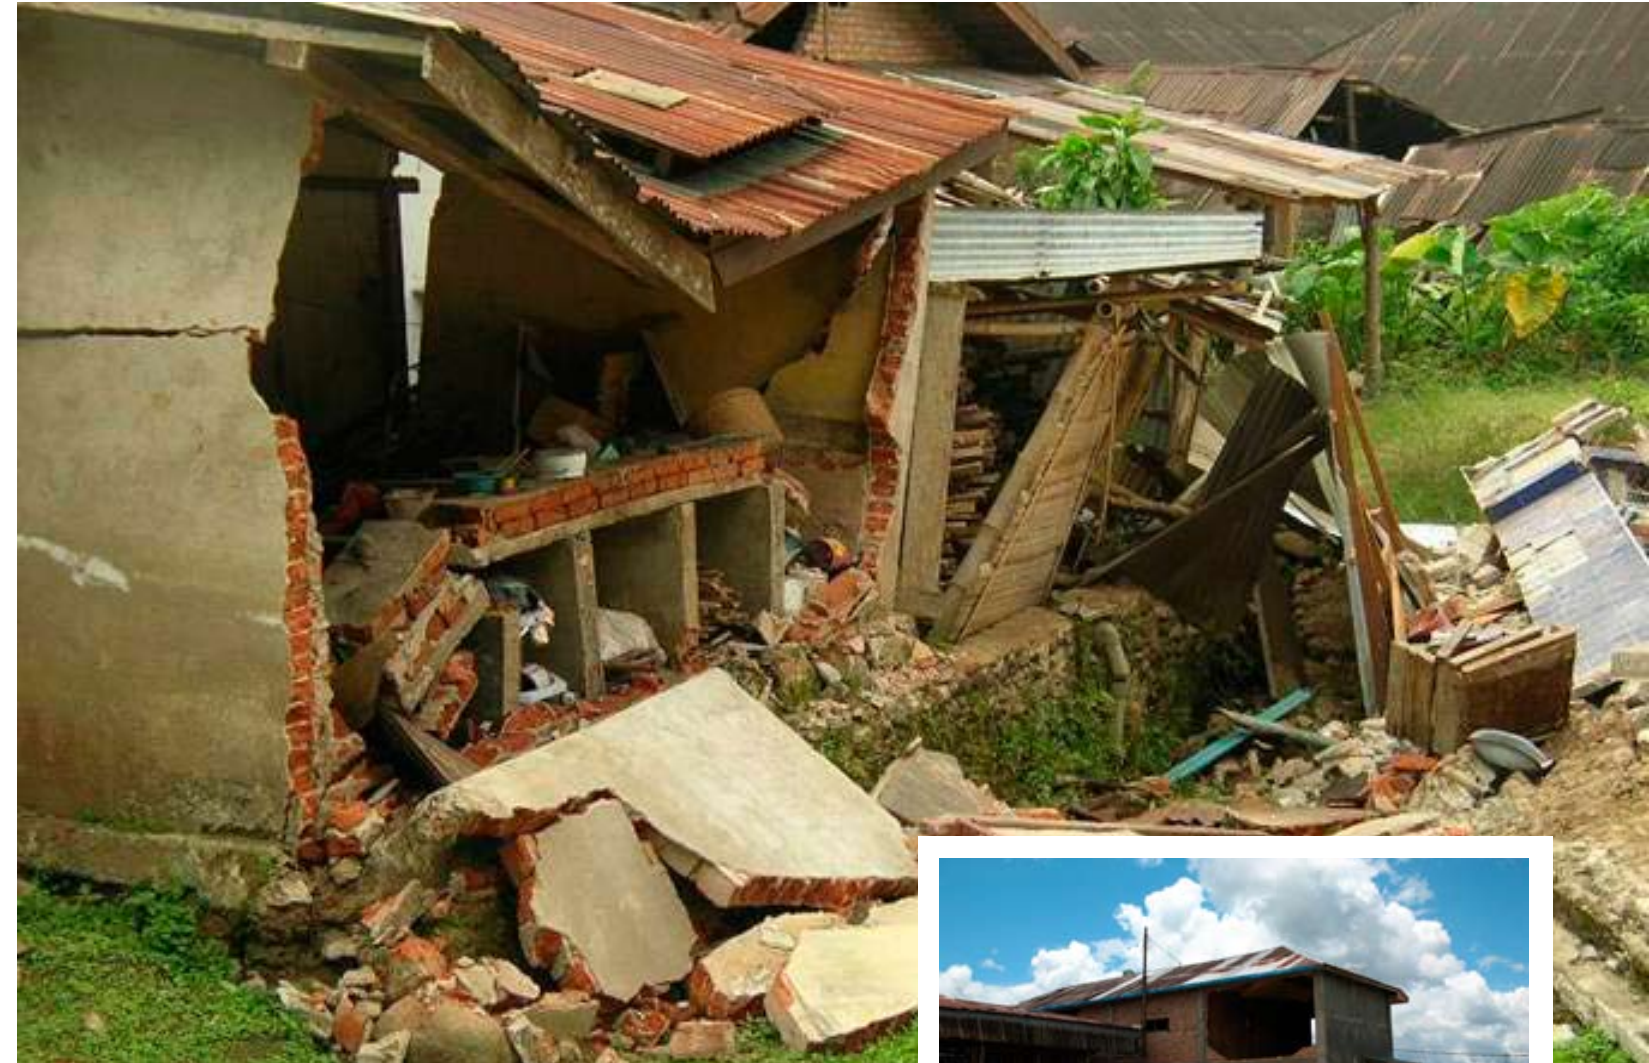
**Figure 8.** These photographs show out-of-plane failure of URM walls. These URM buildings do not have adequate floor diaphragms, and URM walls are not positively connected to the perimeter bond beams and columns. As such, they are not restrained against out-of-plane failure.

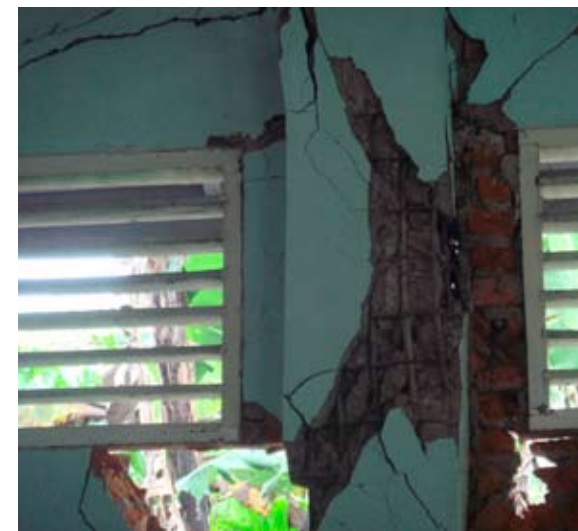
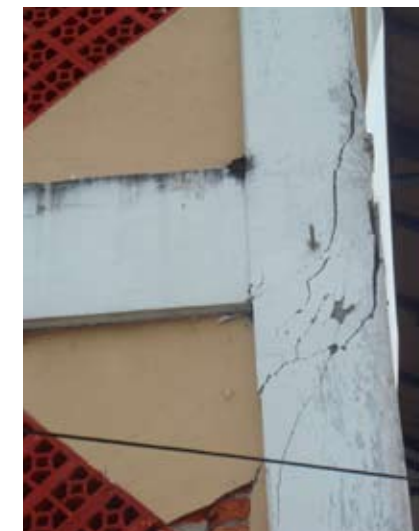
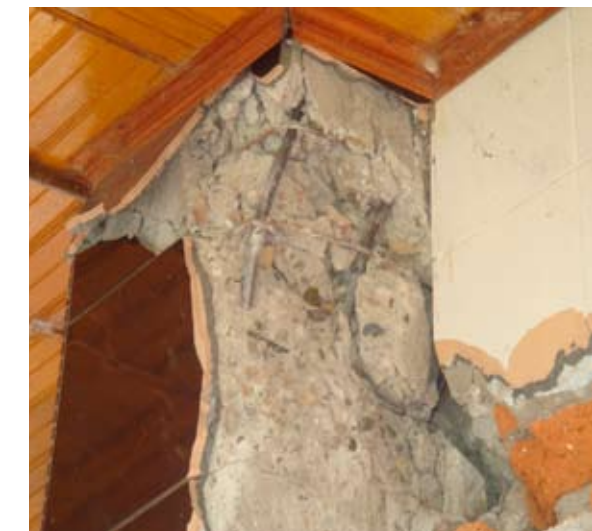
**Figure 9.** The beam-to-column joints for the concrete moment frames do not use ductile detailing. The reinforcement steel does not extend sufficiently into the joint, nor does it have adequate development length. Furthermore, the joints are not confined and hence are susceptible to shear failure.

For URM infills and concrete bond beams, it is recommended to strengthen the beam-to-column joints; see Figure 26. This will avert the brittle shear failure at the joints and will allow the concrete elements to provide some confinement to infills. Most importantly, they will carry the gravity loading and mitigate the building collapse.

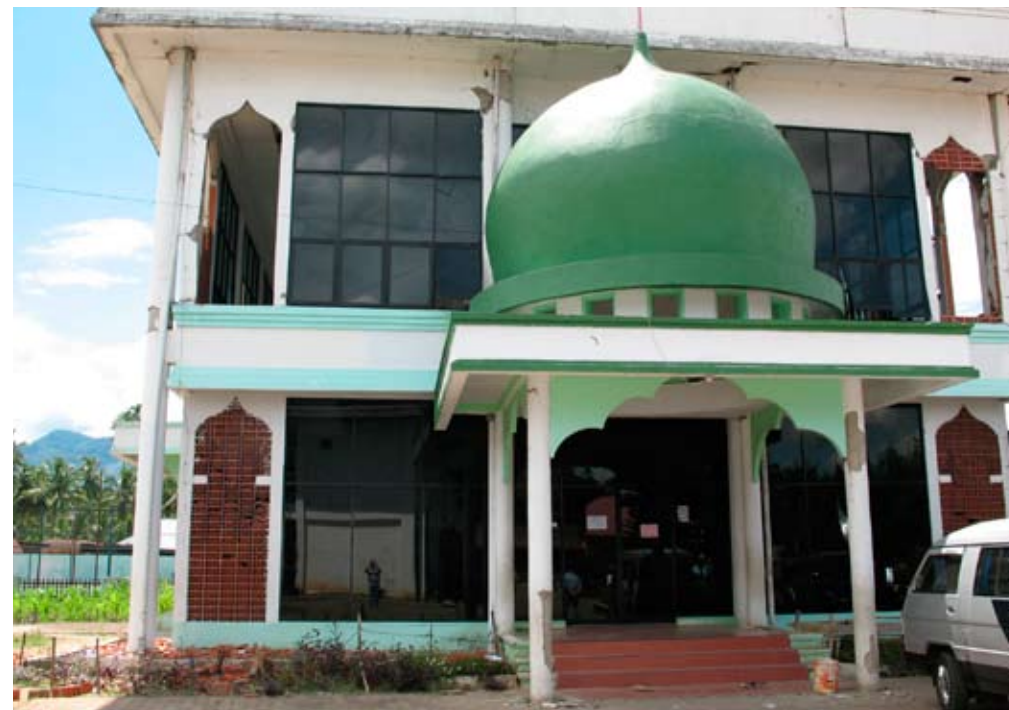
**Figure 10.** This photograph shows typical mosque construction. Note the slender exterior concrete columns. This building was constructed in the mid-1990s.

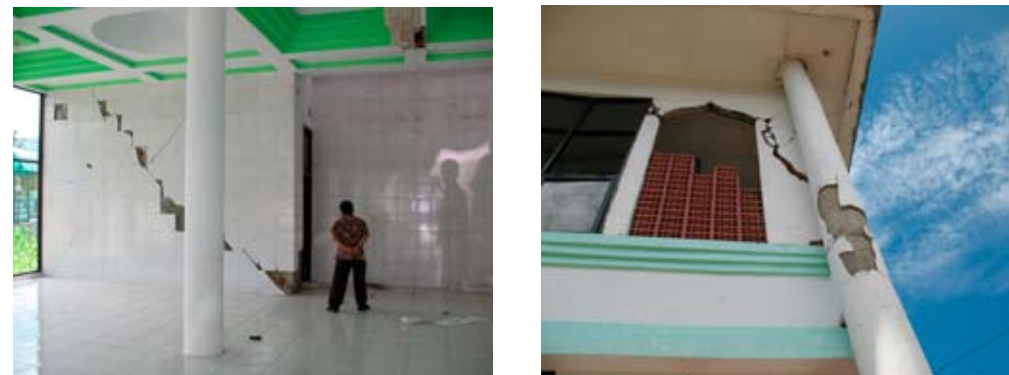
**Figure 11.** These photographs show spalling of concrete from tall, slender column at the story level and shear failure of the interior URM wall. Note that walls are placed on the back side only, and thus the building is torsionally irregular.

To alleviate soft-story and torsional response of mosques and other commercial buildings, either braces or dampers can be added to the first floor of the building; See Figure 27.

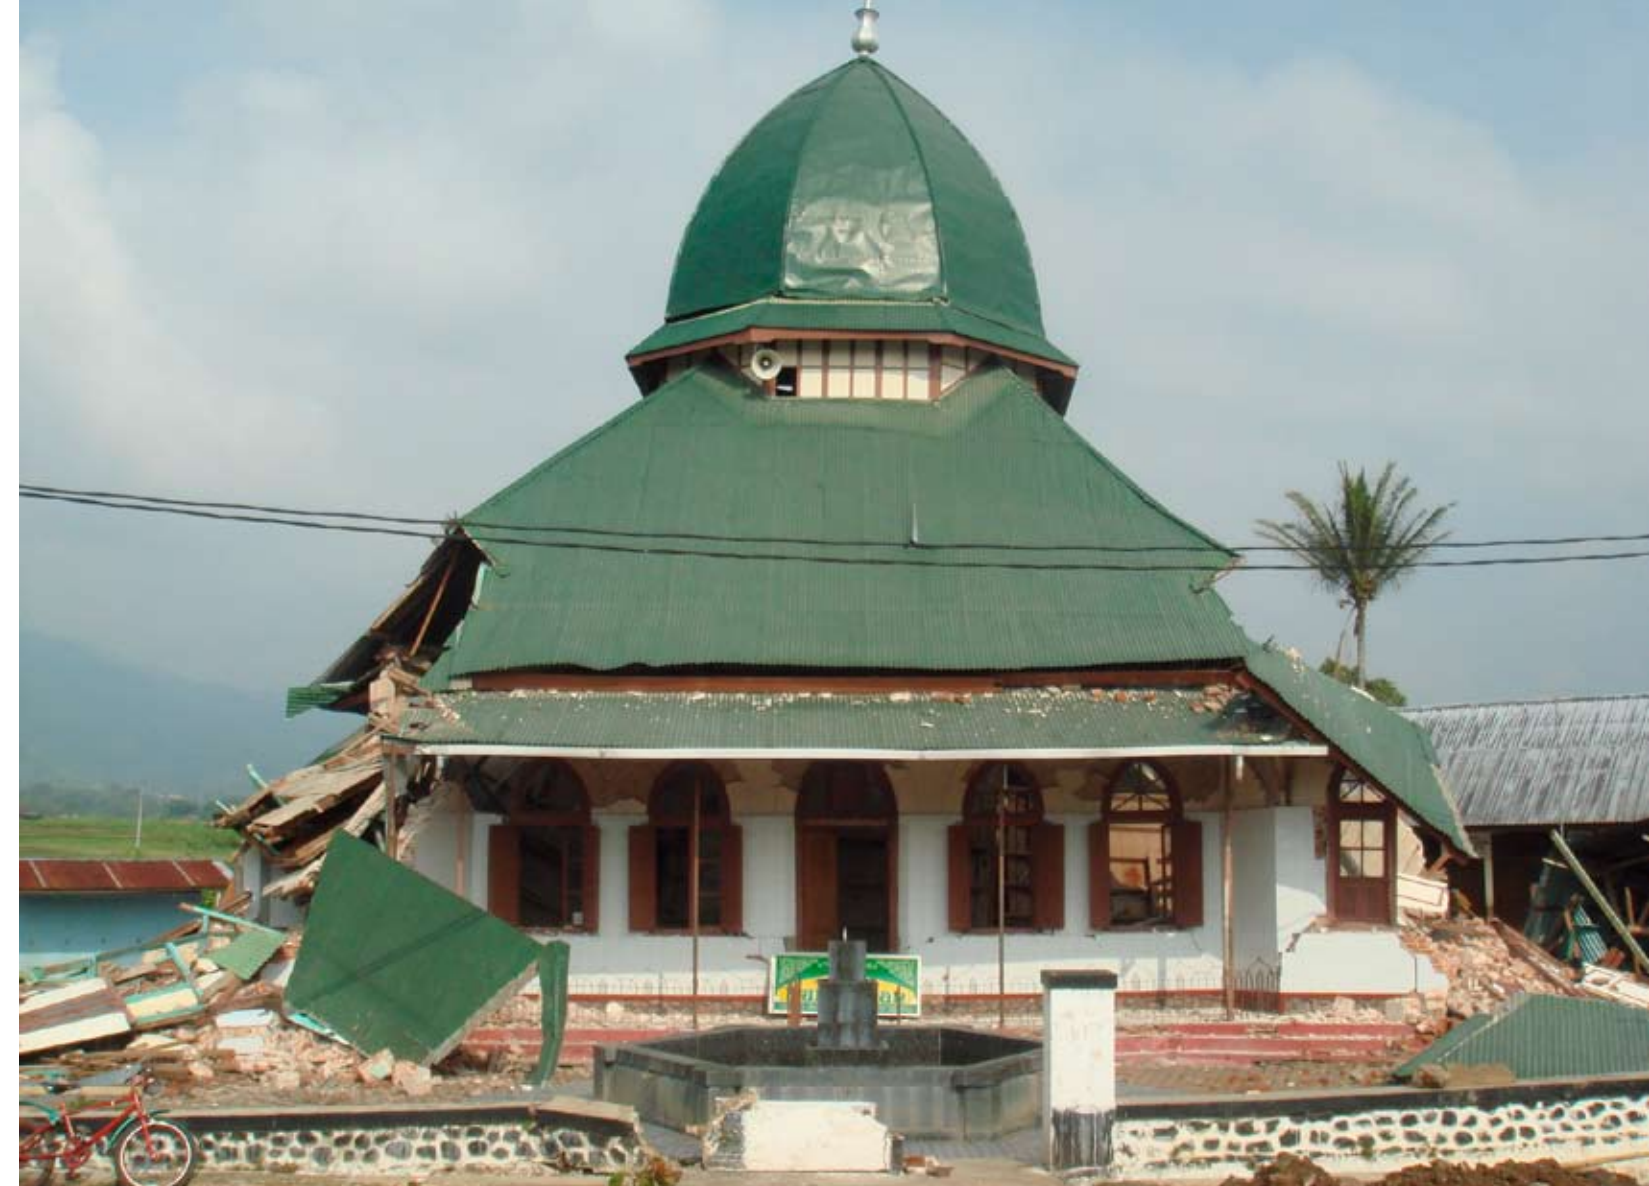
**Figure 12.** Collapse of a mosque is shown in these photographs. The URM walls on the extreme edges of the building collapsed due to the torsional motion.

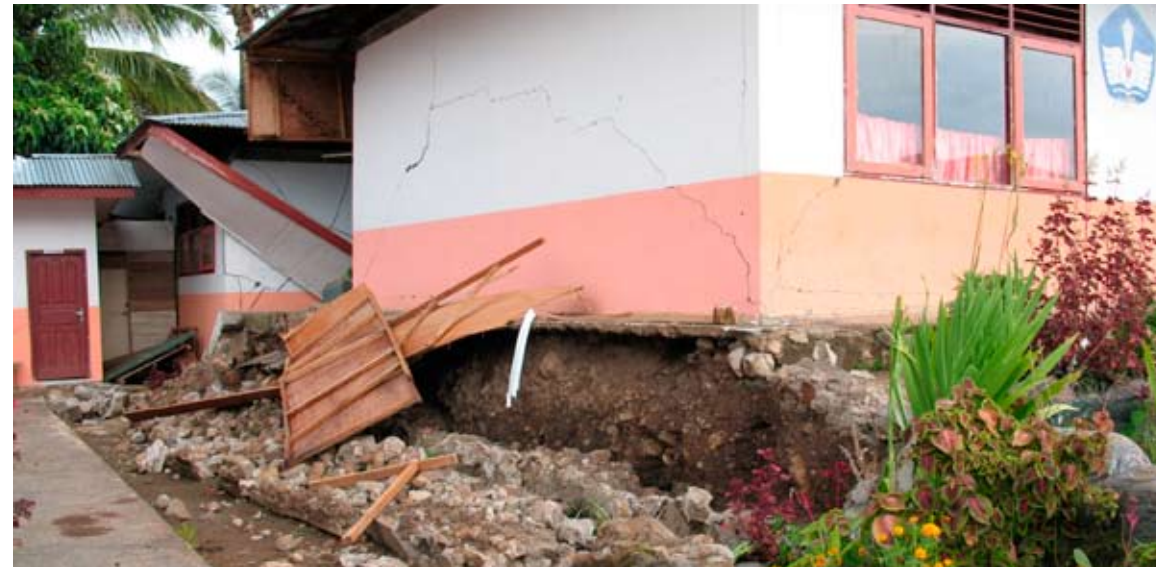
**Figure 13.** The photograph shows unreinforced retaining wall failure of a school building. Note the diagonal shear cracks on the URM walls at the side of the building.

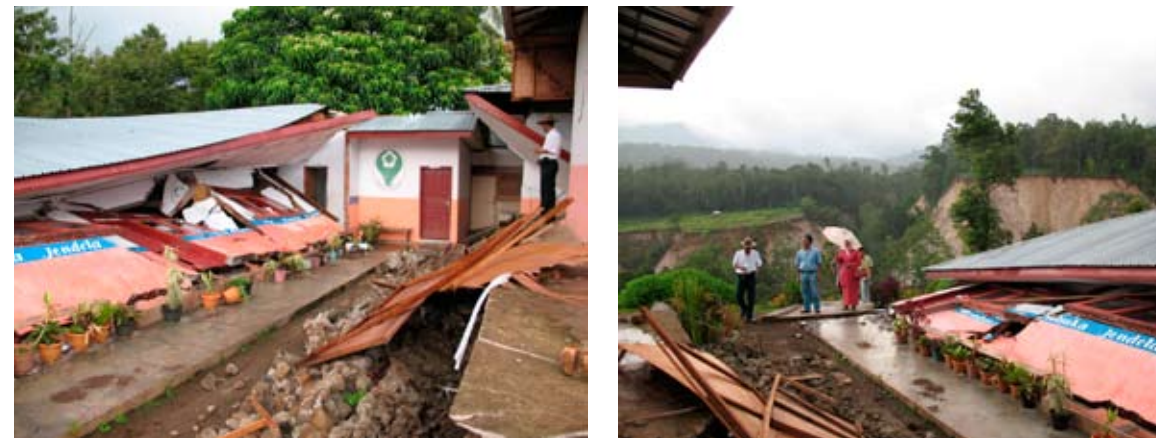
**Figure 14.** These photographs show out-of-plane collapse of URM walls. The walls were not adequately anchored to the foundation or roof diaphragm to restrain the URM walls. The Sumatra Fault is shown in the near distance. The roof diaphragm, perimeter concrete beam, and columns were weak.

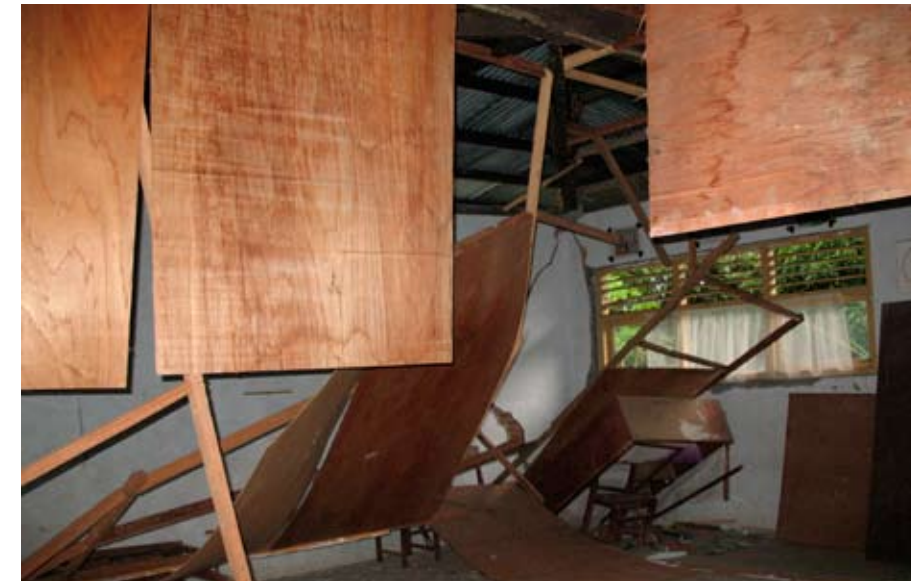
**Figure 15.** The photographs show nonstructural damage to a school building. This building did not sustain any structural damage. However, the ceiling and soffit collapsed. Unless these elements are properly designed and anchored, they are life-safety hazards. For this school building, ceiling panels collapsed in the classrooms, and roof soffit panels dislodged.

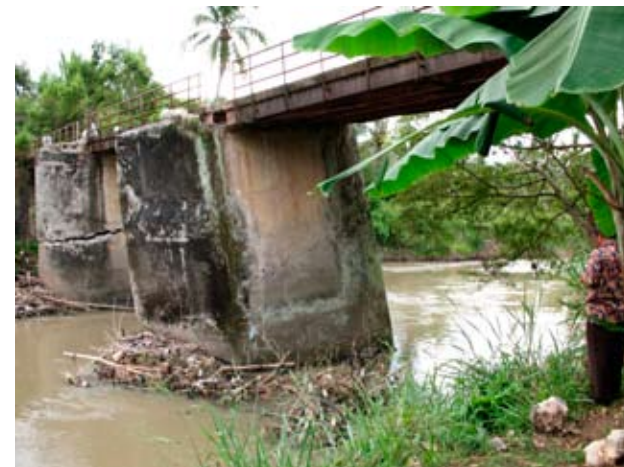
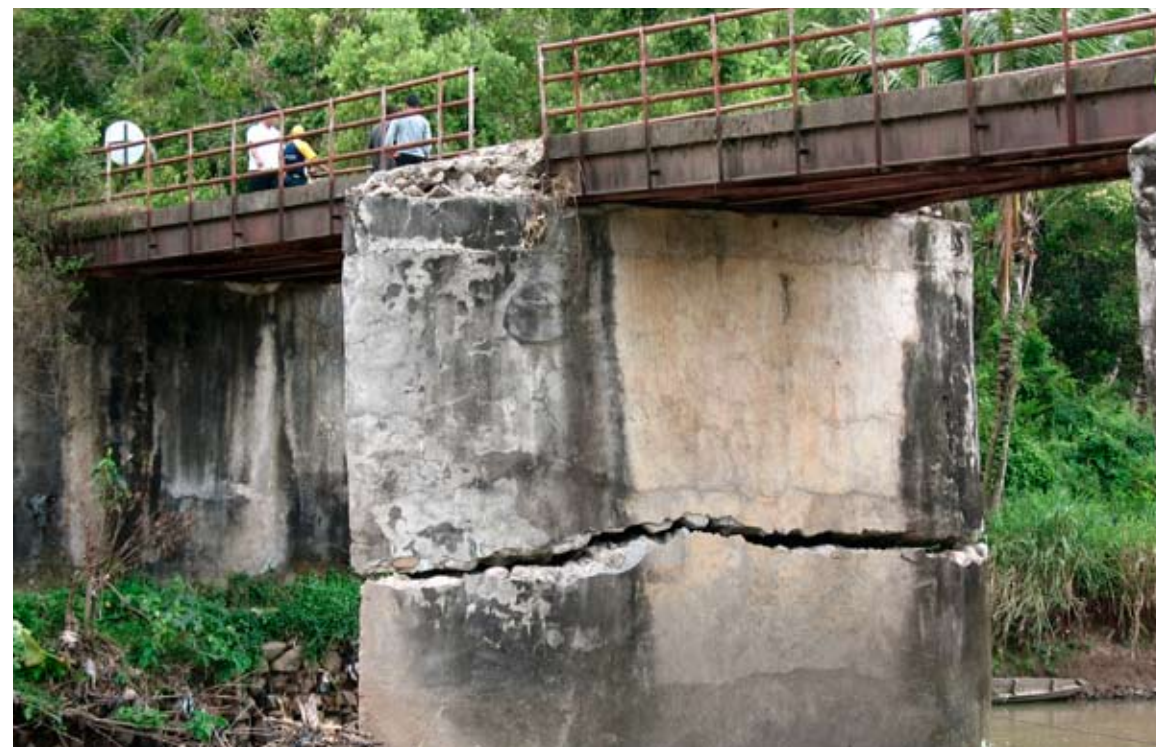
**Figure 16.** The photographs show failure of piers for the concrete bridge. A heavy deck and bents contribute to high seismically induced force experienced by the bridge, which caused the brittle shear failure in one bent and rocking at another. This bridge is near collapse, and traffic has been redirected.

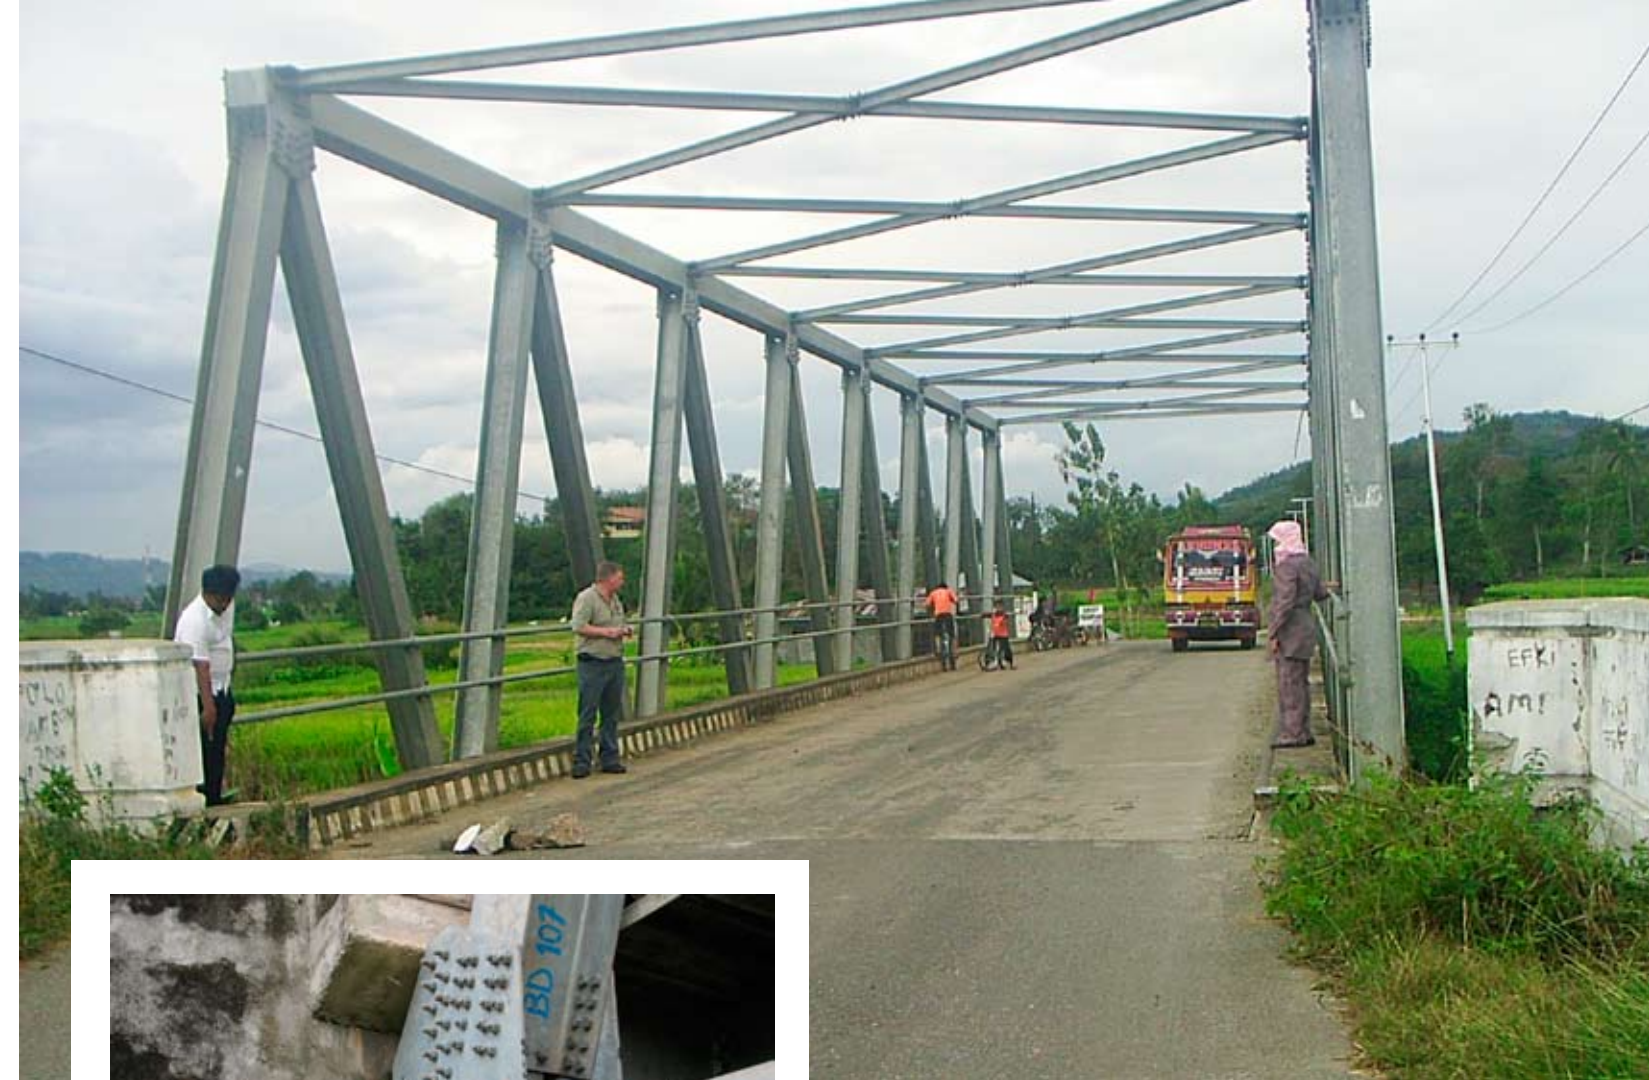
**Figure 17.** This photograph shows a steel truss bridge located in the earthquake-impacted area. Note that the superstructure did not sustain any damage. However, the bridge had an inadequate transverse shear key, and its abutment bearings had insufficient movement capacity. The steel members in this bridge appeared to be undamaged.

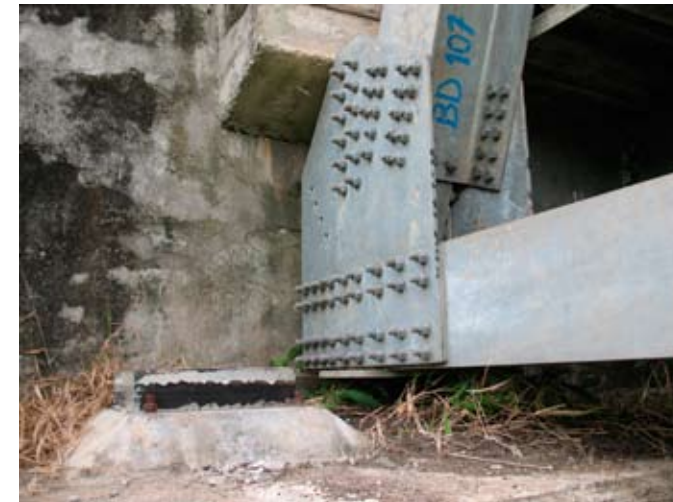
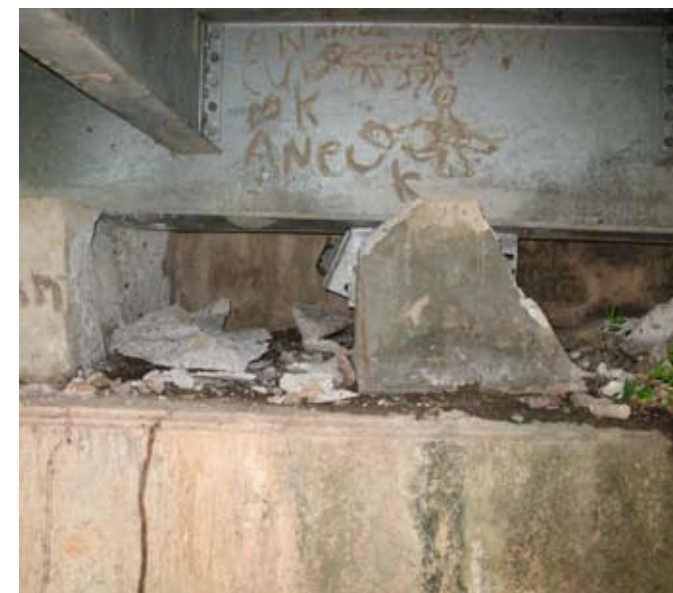
**Figure 18.** The photographs show failure of the substructure elements for the same steel truss bridge. The bridge is supported on bearings at the abutments, and it did not have an adequate transverse shear key. During the earthquake, the bridge slid off its bearings. The bearing pads did not have adequate width and/or restraint to allow or resist the seismic movement.

For bridges that are supported at the abutments on inadequate bearing pads, seismic isolation pads provide an attractive replacement alternative. This isolation system will serve to reduce the inertial forces transferred to the substructure. Additionally, a well-designed system with adequate transverse shear keys would prevent the type of failures observed during this earthquake.

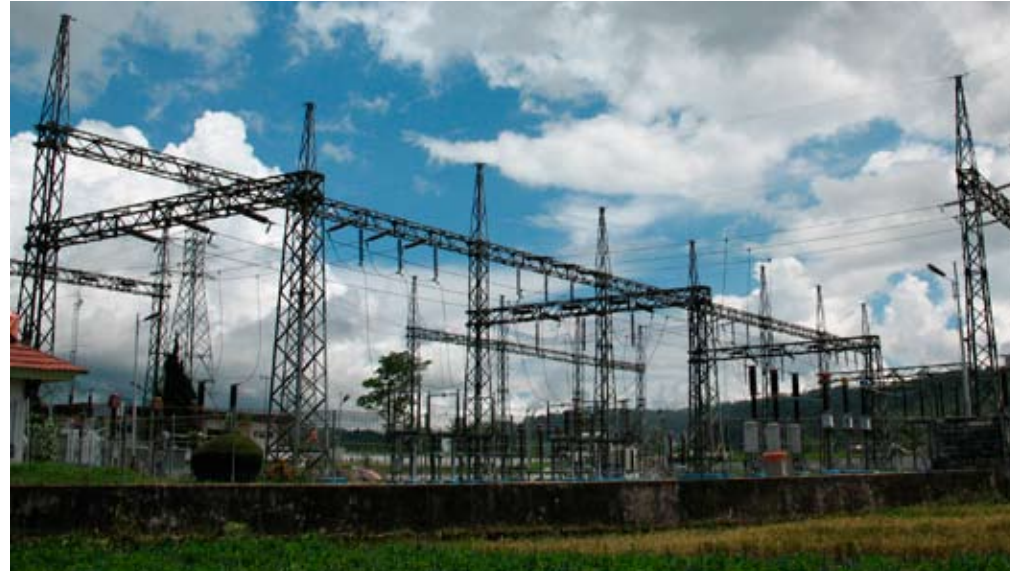
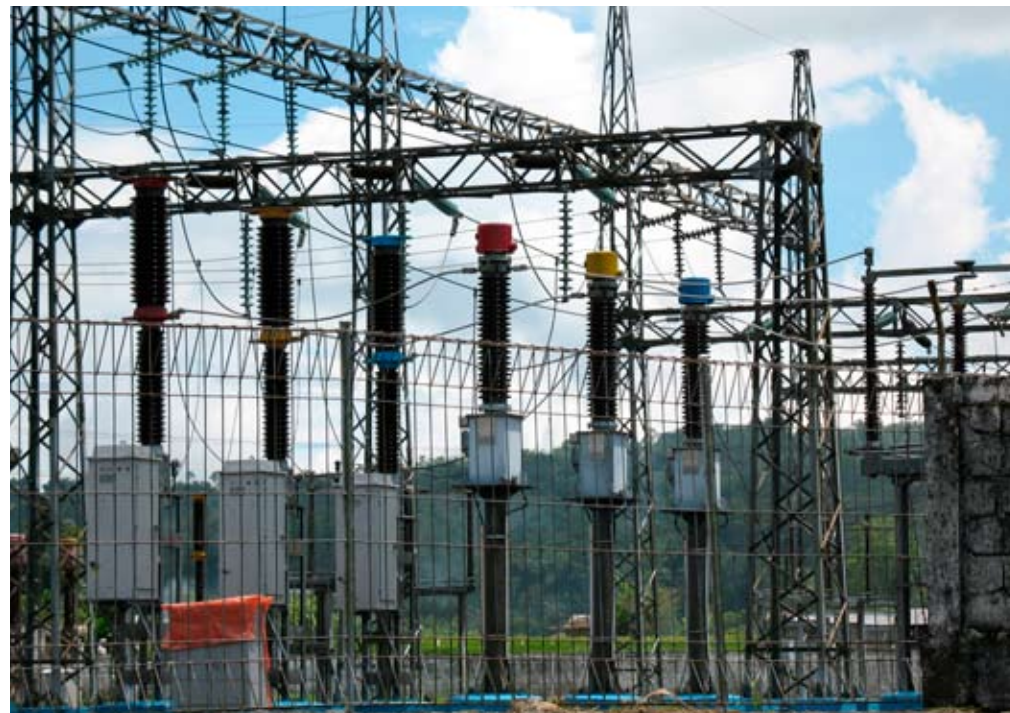
Immediately after the earthquake, the power was disconnected. Post-earthquake investigation showed that one of the bushings had tipped over. The bushing was not damaged. It was re-erected in the upright position, and electricity was restored within two days. The water and wastewater facilities were not damaged. The telephone lines were operational.

**Figure 19.** The local electric substation and its bushings are shown above. One bushing fell and caused a blackout for a few days.

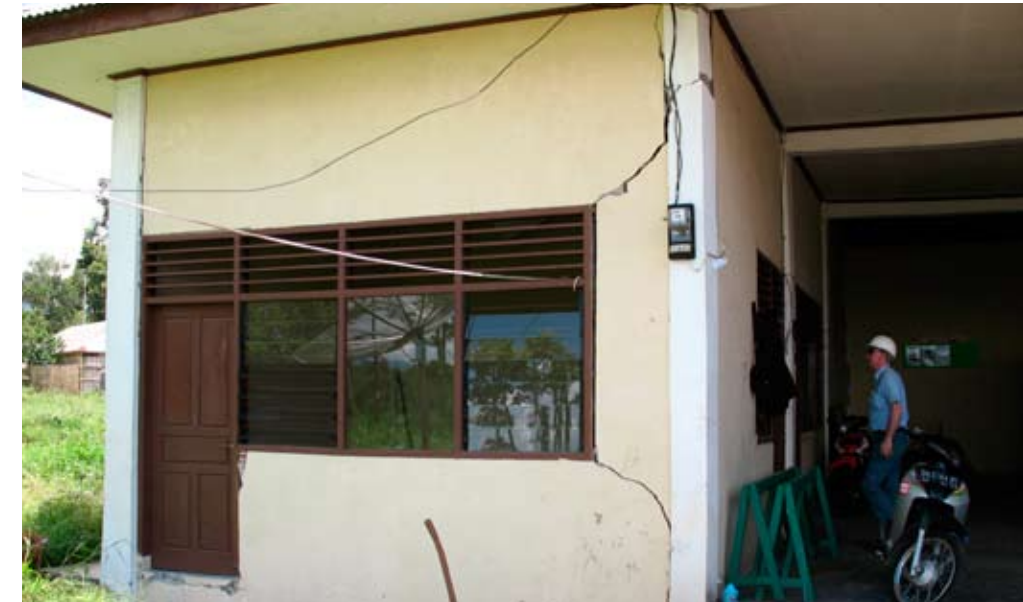
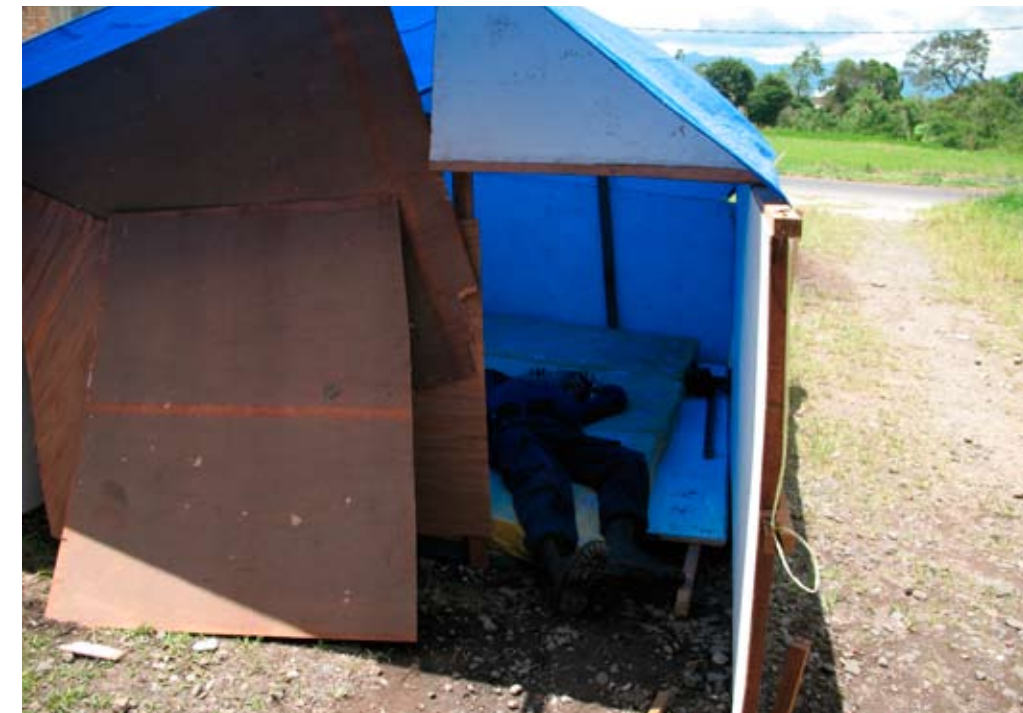
**Figure 20.** A damaged local fire station building, with the cracked URM wall is shown in the top photograph, and temporary shelter for five firefighters is shown in the bottom photograph.

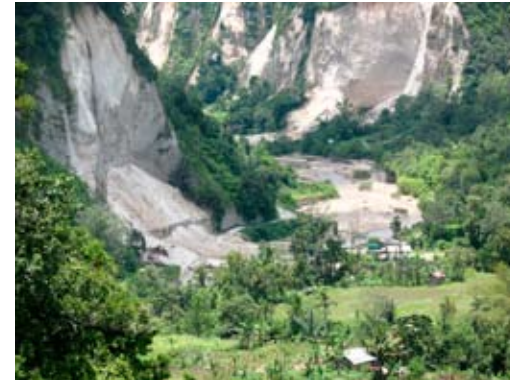
**Figure 22.** A large landslide caused by the earthquake is shown in this photograph. Note the roadway at the bottom of the landslide. This slide buried four houses.

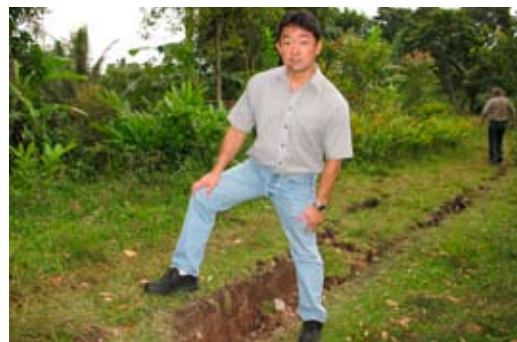
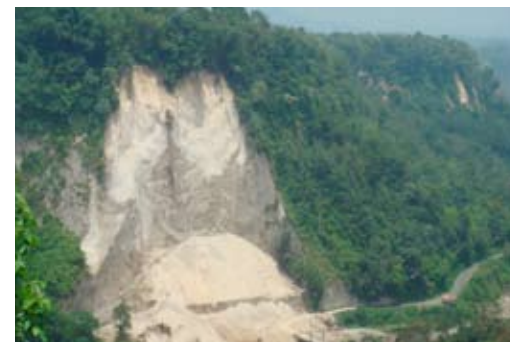
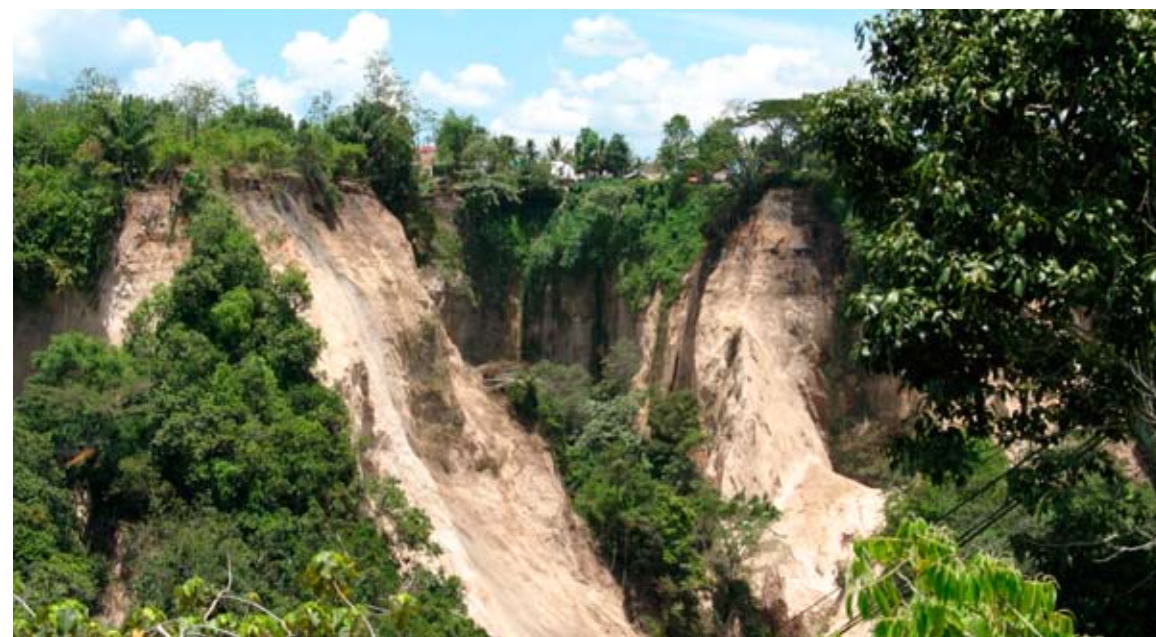
**Figure 23.** As shown in these photographs, the earthquake also caused noticeable ground rupture both horizontally and vertically. Note the large section of slope instability next to the Great Sumatra Fault in the bottom photograph.
