L'Aquila, Italy Earthquake Journal

H. Kit Miyamoto
Global Risk Miyamoto

Journal Entry #1

April 14 - L'Aquila, Epicenter

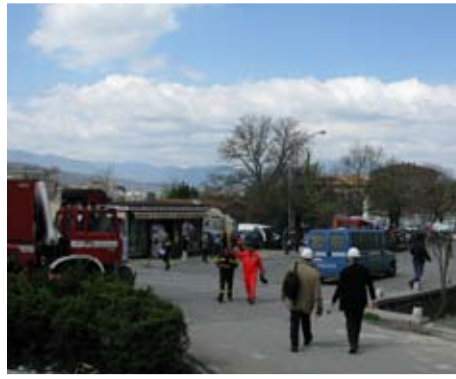
We parked our car at the army and police guard gate, which goes to the old town center. I saw much local TV coverage that showed intense damage in this area. Since the buildings in this area were so unstable and dangerous, the whole old city center was off limit to unauthorized personnel. A fire chief stopped us and asked us to come back later today to investigate the cordoned area.

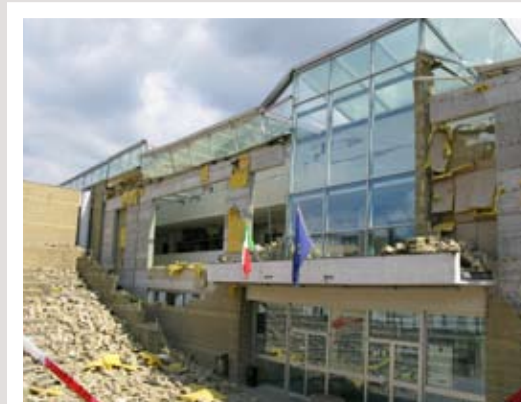
We met a couple of professors from the local L'Aquila University. Peter knew them from UC Berkeley. We followed their cars to their engineering school at the top of hill. They told us that there was major damage to their school buildings.

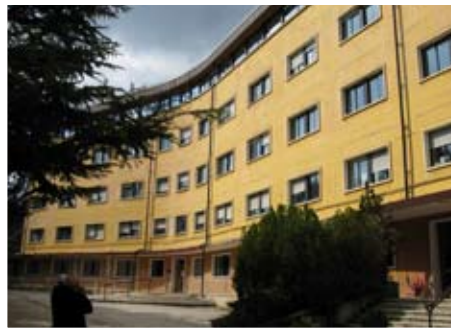
We next entered the older faculty building. We were told that this 5-story building was built in the 1930s.
