L'Aquila, Italy Earthquake Journal

H. Kit Miyamoto
Global Risk Miyamoto

Journal Entry #4

April 16, 2009, 7:30 am - The Journey to the Epicenter

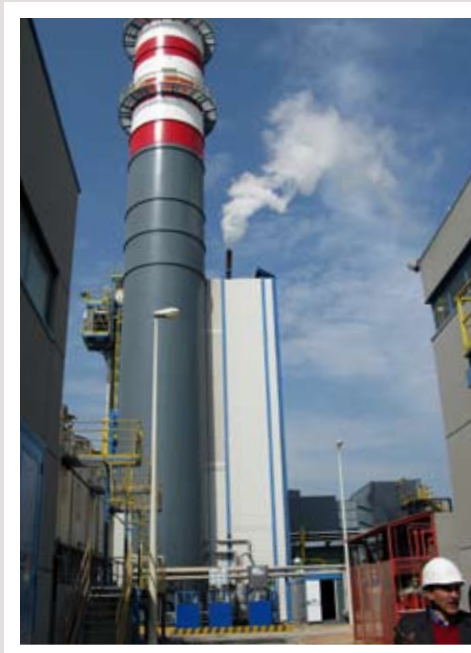
9:35 am - The Power Plant

We stopped at a 1999-built combined cycle, 180 MW power plant with three sets of boilers in the town of Celano, which is about 30km from the epicenter. The plant manager gladly gave us a tour of the plant. He wanted us to point out any earthquake damage and weaknesses that can be improved for future earthquakes.

The plant buildings and structures were well engineered steel structures that appeared undamaged. These were the only steel

framed buildings that we have observed so far. Some of the equipment, particularly the generation related equipment was anchored properly. Much of the other equipment, however was not anchored properly for earthquakes. We pointed out some of the weaknesses in equipment systems. The emergency battery racks was not braced and the batteries were not protected against falling off their racks. Batteries seem so trivial, but are crucial for turbine operations after an earthquake triggered stoppage.

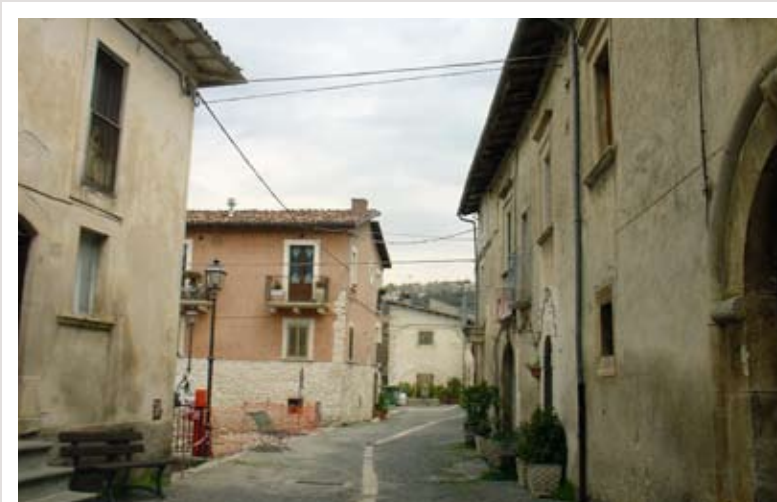
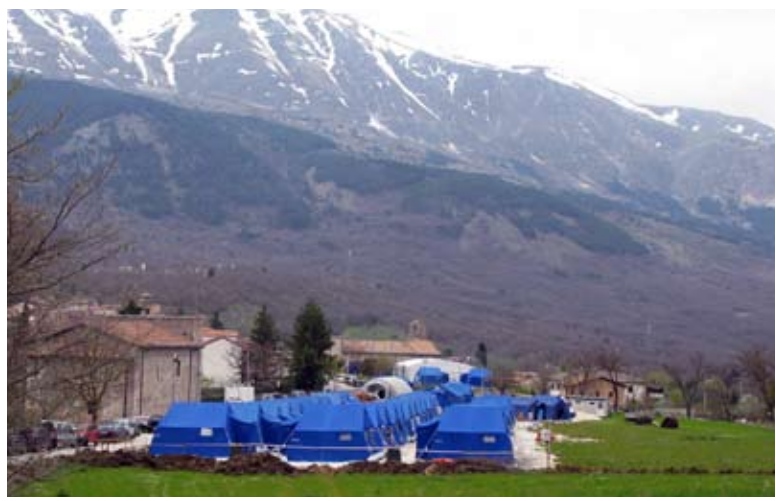
12:35 pm - Ghost Towns and Blue Tents

Highway 5 north reached 1,500 meters and placed us in an alpine meadow surrounded by snow capped mountains. This scene was dotted with ancient villages. We drove through several and found them to be strangely deserted. No people and all businesses were closed. There wasn't any apparent damage to the buildings. In one village, we found a cluster of government issued blue tents at the edge of town. That's where all the people went. They were really scared of the buildings and didn't want to stay in them.

I saw this same problem in China last year. There was no formal post-earthquake engineering inspection program to assess building damage and to let people know if they can safely reoccupy their homes and businesses. Not doing so increases the homeless problem, adds cost and slows overall recovery. We are fortunate in Japan and California where thousands of pre-trained volunteered engineers will inspect buildings and give them red, yellow or green tags. Green is for safe entry. Red is unsafe to enter.

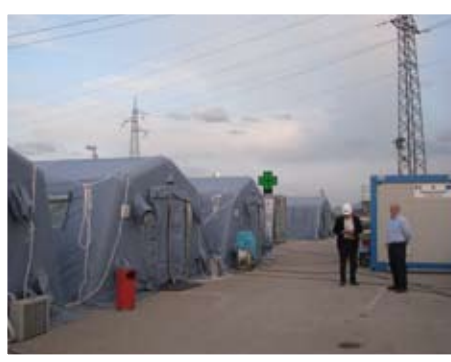
With exterior walls gone, the concrete beams and columns were exposed. These walls were masonry infill walls similar to those that we saw at the college on day one. The hospital was dark and totally deserted. The ground motion here was not strong enough to collapse the structural system, but the unanchored masonry walls didn’t have a chance. Interestingly, other buildings nearby didn’t have much damage—a testament to the low ground motions.

Emergency hospital operations were moved to an outside tented area in the rear parking lot. We talked to a neurology doctor about the situation and he was told that the damage was superficial and they were hoping to move back to the hospital.

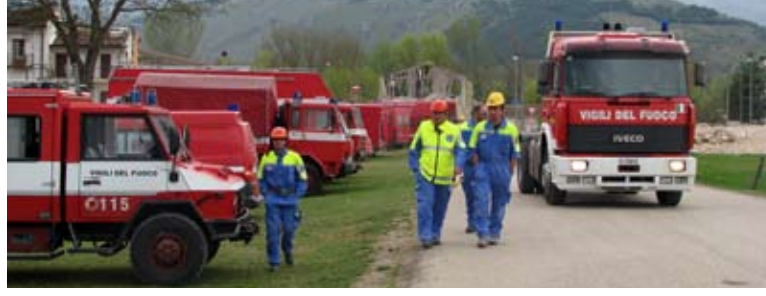
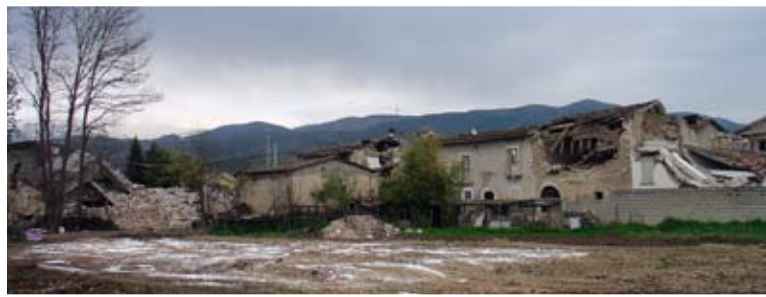
7:10 pm - Onna

about to collapse. Soft soils in this river meadow area may have contributed to the higher ground acceleration and destruction. Earthquake motions tend to increase in soft soil areas. These residential buildings were made of unreinforced brick and concrete floors, one of the most dangerous building types. This same system killed many of 100,000 in China last year. The lesson is repeated here. We spoke with some police officers who explained that over 40 people were killed in this village of 300. We saw a 3-story building completely leveled to the ground. This type of collapse doesn't allow people any chance to escape. I smelled the familiar sweet scent of crushed buildings, dust and belongings.

Dusk is setting in and hundreds of firefighters and emergency personnel are wrapping up another day of search and rescue work. They walk quietly and respectfully around the destroyed buildings—a large grave yard in a beautiful meadow...
