# 2007 West Sumatra Earthquake

Reconnaissance Report

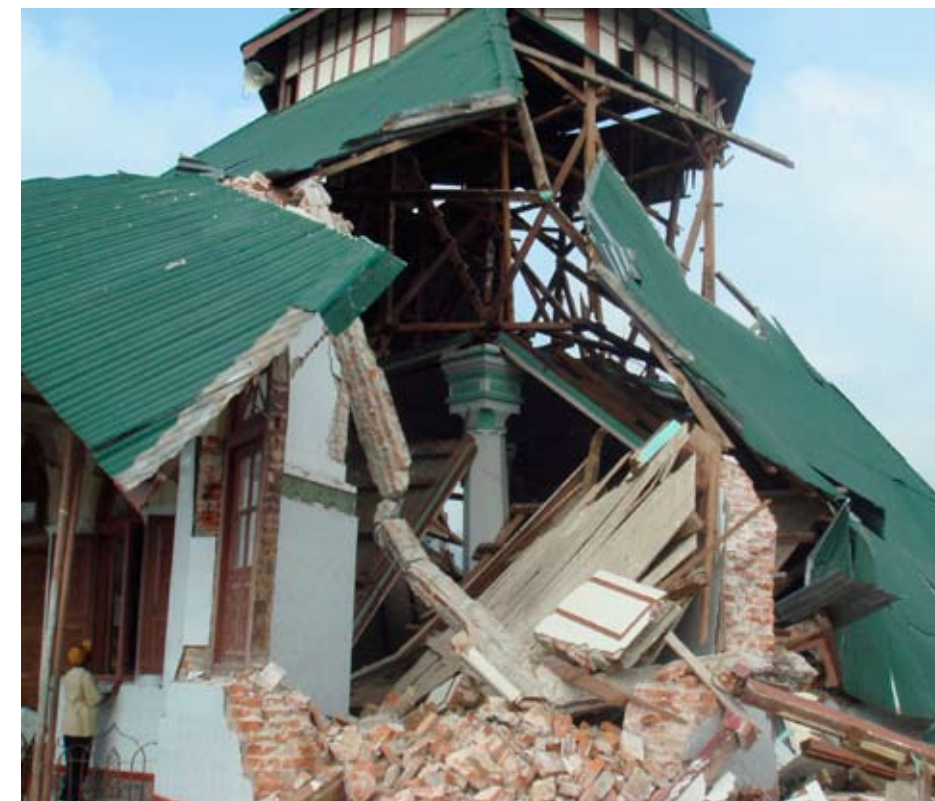
**Figure 12.** Collapse of a mosque is shown in these photographs. The URM walls on the extreme edges of the building collapsed due to the torsional motion.

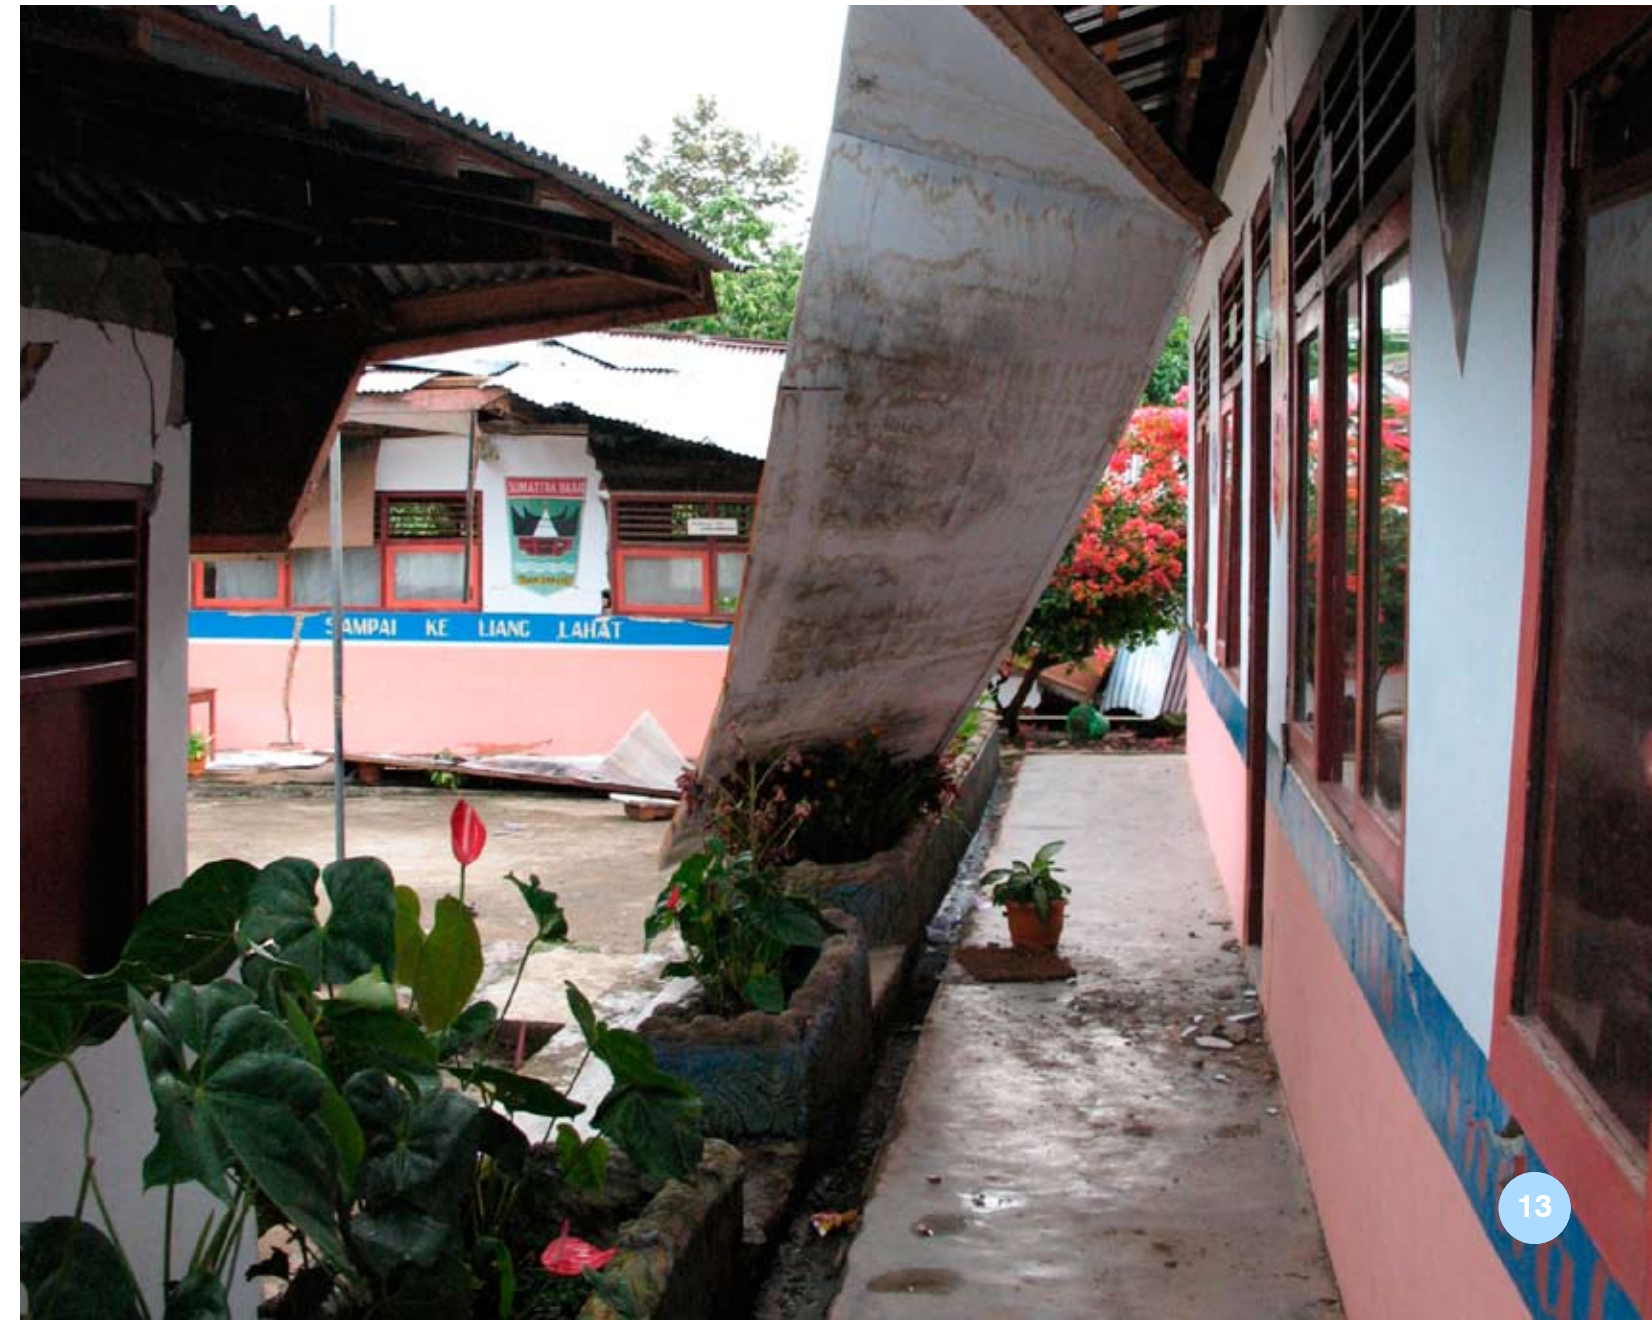
**Figure 15.** The photographs show nonstructural damage to a school building. This building did not sustain any structural damage. However, the ceiling and soffit collapsed. Unless these elements are properly designed and anchored, they are life-safety hazards. For this school building, ceiling panels collapsed in the classrooms, and roof soffit panels dislodged.

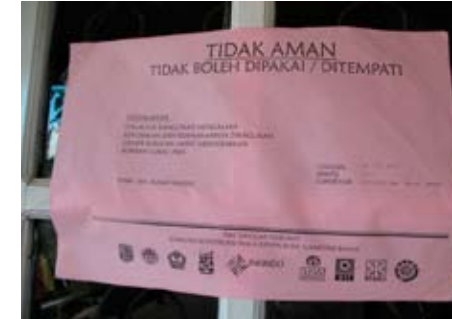
**Figure 24.** A red-tagged building is shown in the top photograph, and seismographs at the local seismological station are shown in the bottom photograph.
